**An Engineering Geological Investigation  
of Waikawa Bay and Whatamango Bay,  
Marlborough Sounds,  
New Zealand.**

A thesis  
submitted in partial fulfillment  
of the requirements for the Degree  
of  
Master of Science in Engineering Geology  
at the  
University of Canterbury  
by  
Sonia T. McManus

**University of Canterbury  
1996**

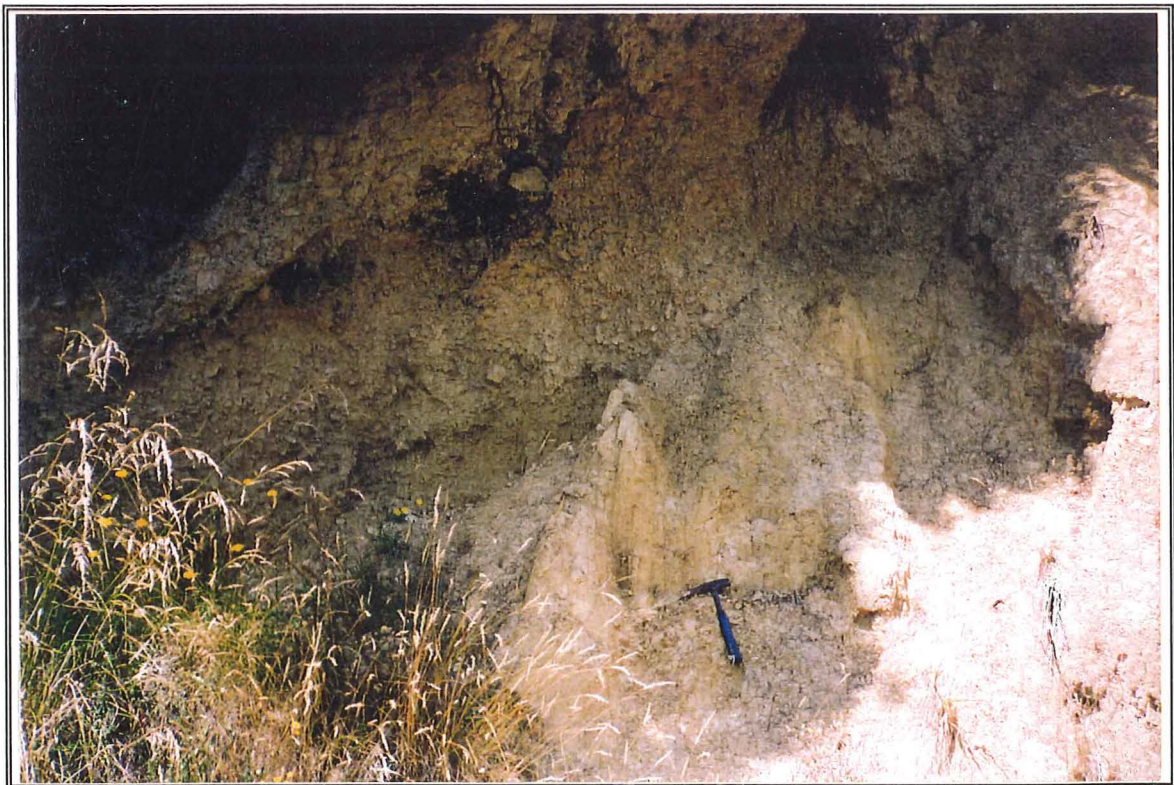
*Figure 3.4.: A colluvial profile over bedrock showing the random orientation of colluvial clasts and the uneven contact of colluvium over bedrock.*

In the field fine-grained matrix-rich colluvium may be difficult to distinguish texturally from insitu weathered bedrock, however the method of emplacement differs markedly because colluvium is the product of weathered bedrock which has been transported downslope by gravity and/or slope wash processes. Regolith is here defined in comparison as insitu weathered bedrock which has not been subject to any transportation downslope. The clasts in regolith thus reflect the original orientation of features such as bedding and jointing in unweathered bedrock. In contrast to regolith clasts, all clastic fragments in colluvium are angular to sub-angular and have a distinctly random orientation (Figure 3.4.). Figure 3.5. is a diagrammatic representation of the orientation of clasts within colluvium compared to those present in regolith deposits showing the random orientation of clasts in the colluvial material. Due to the slope wash mechanism of transportation, colluvium varies in texture reflecting proximity to the original weathered surface. Coarse and poorly sorted blocky colluvium contains angular clasts 30-40 cm in diameter, which indicates that the material has not been transported far from the original source area, and because these deposits occur on the higher slopes (above 200m) they are thought to represent periods of mass wasting during periglacial climates in the field area (Kingsbury, 1987). The blocky slope failure deposits have subsequently undergone chemical weathering during the interglacial periods to produce a silty clay matrix. Additionally the size of the clasts in the blocky colluvial material reflects the joint spacing and degree of fracturing within the original bedrock material.

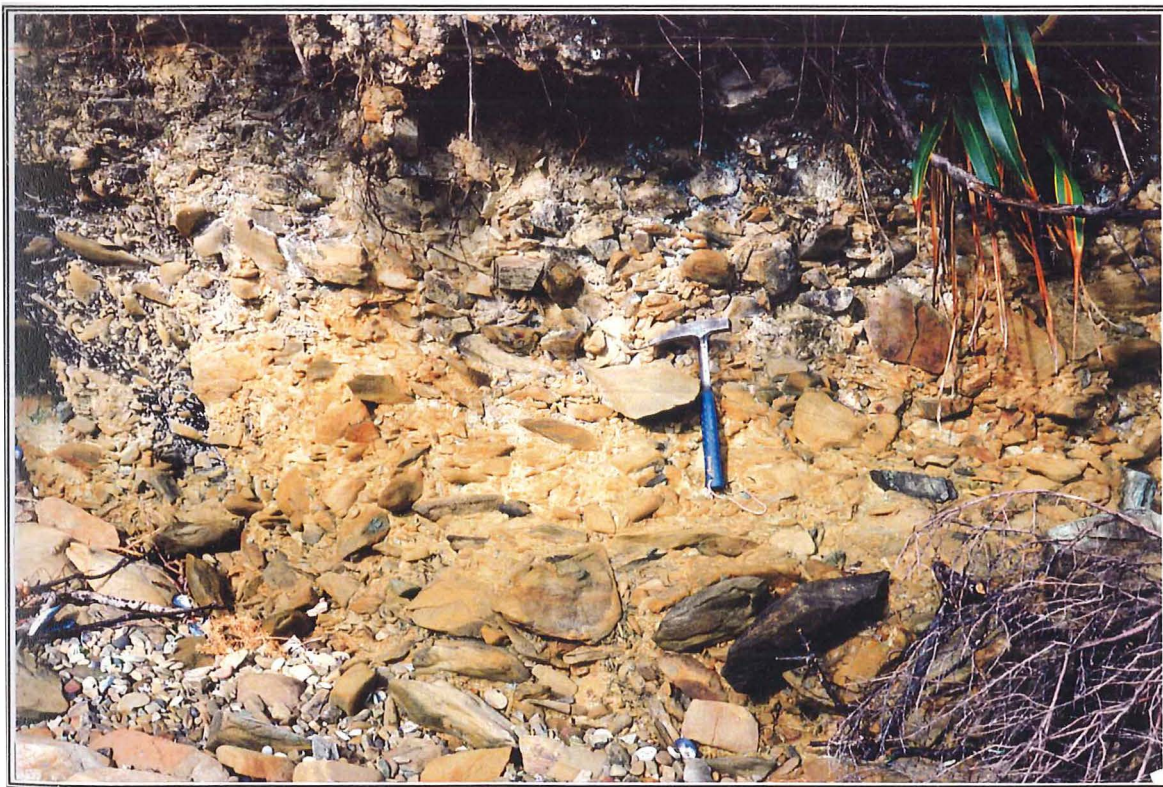
**FIGURE 3.9.:** A debris flow deposit at the base of a gully in Whatamango Bay. The deposit shows complete disorientation of clasts within the matrix and the largest clast measures >30cm in diameter (GR P27 259995 599320).

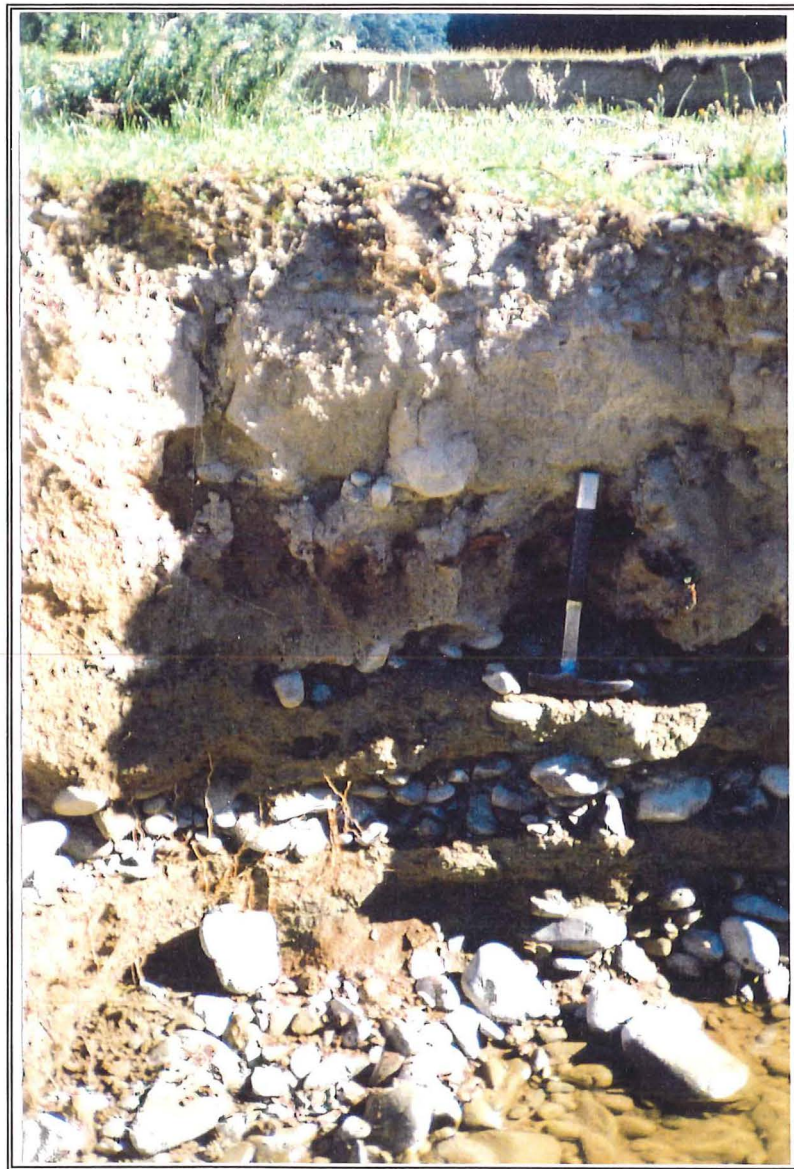
**FIGURE 3.12.:** *Flood plain alluvium in the Graham River showing different episodes of deposition reflected in grainsize changes. Coarse gravels indicate channel deposits while silty clay material represents overbank deposits. Note the imbrication of the gravels in the terrace alluvium.*

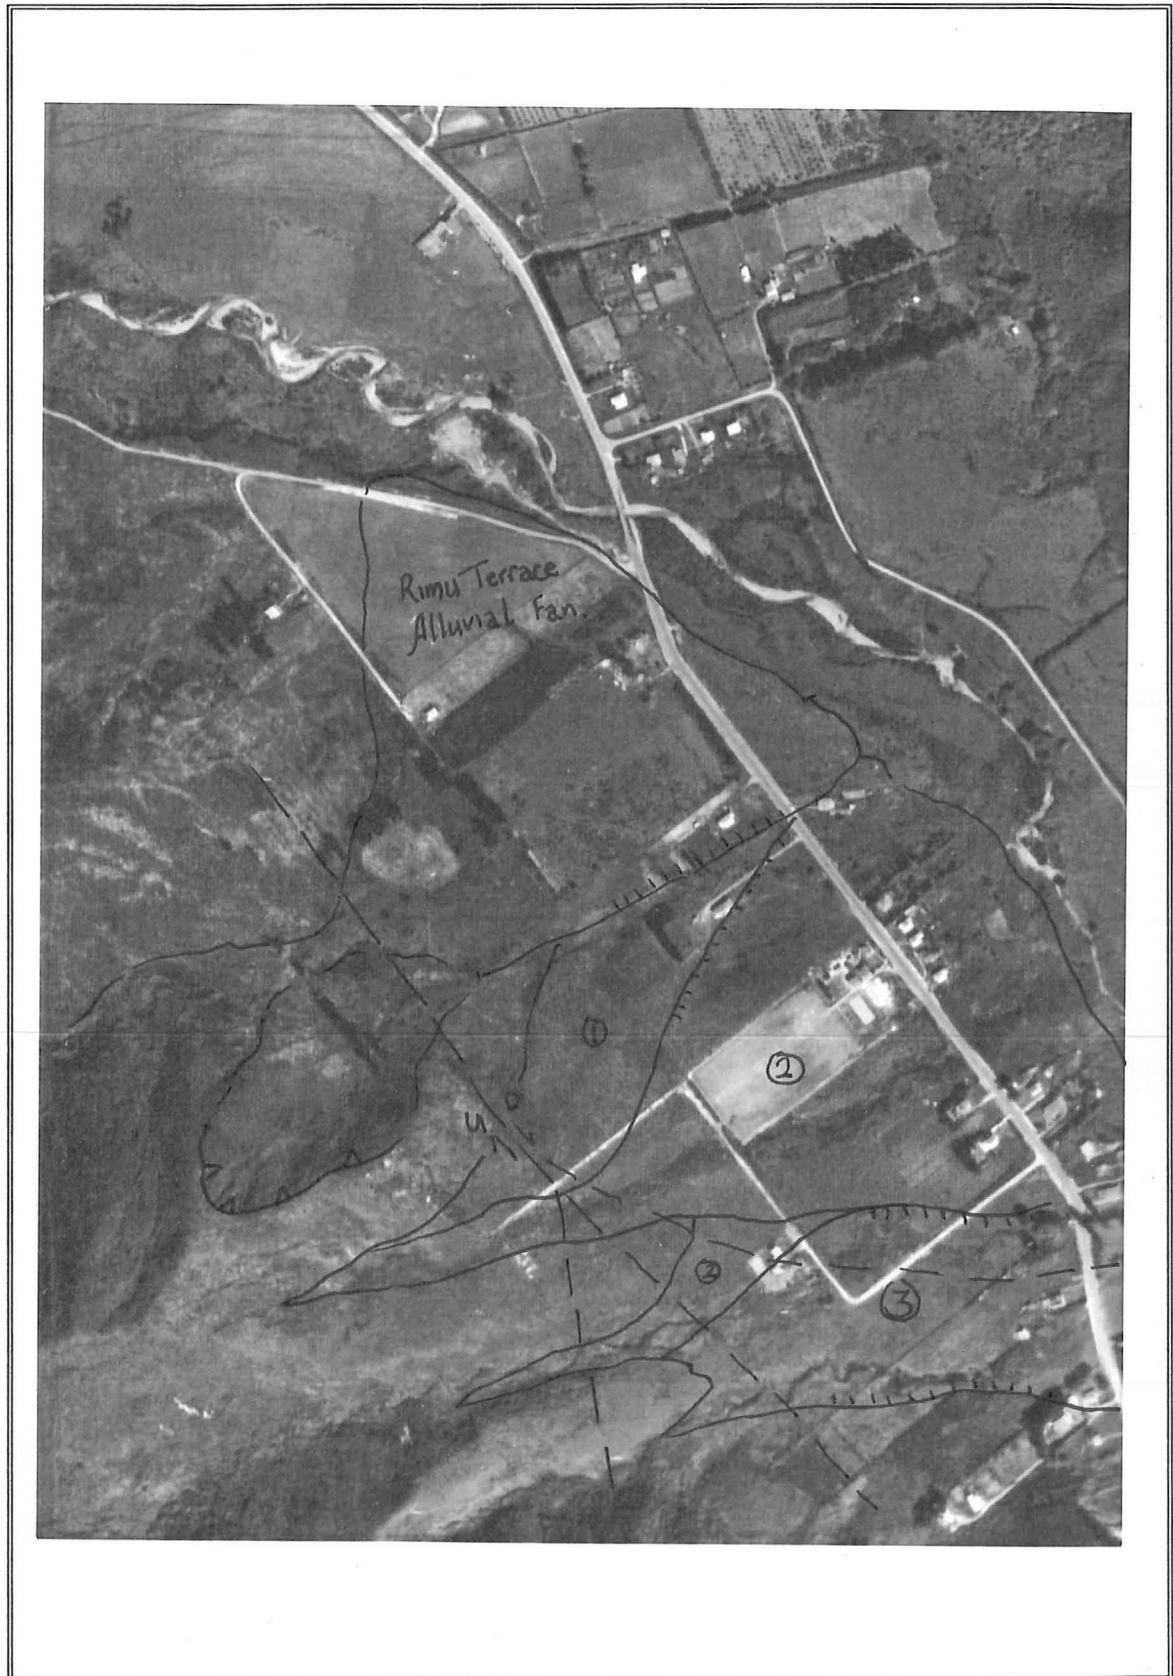
FIGURE 4.1.: A location map which shows the relationships between the geomorphic surface and the Waikawa Bay Fault in the field area. The Maori Cemetery debris fans are represented in decreasing age of deposition; ① being the oldest fan, ② the next youngest, and ③ the youngest fan.

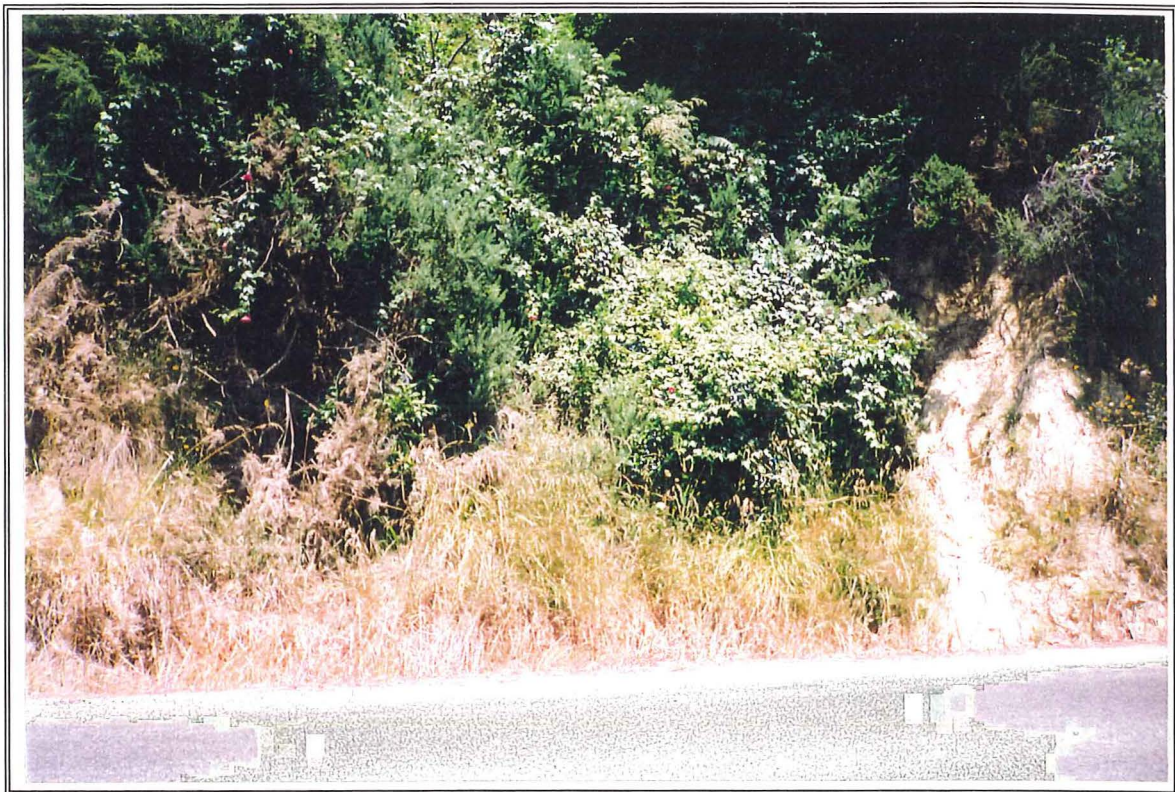
FIGURE 6.12.: A photograph and diagrammatic sketch of the colluvial wedge above the Manuka Cottage site. The wedge is thought to indicate a relict gully system upon which Manuka Cottage was at least partially built.

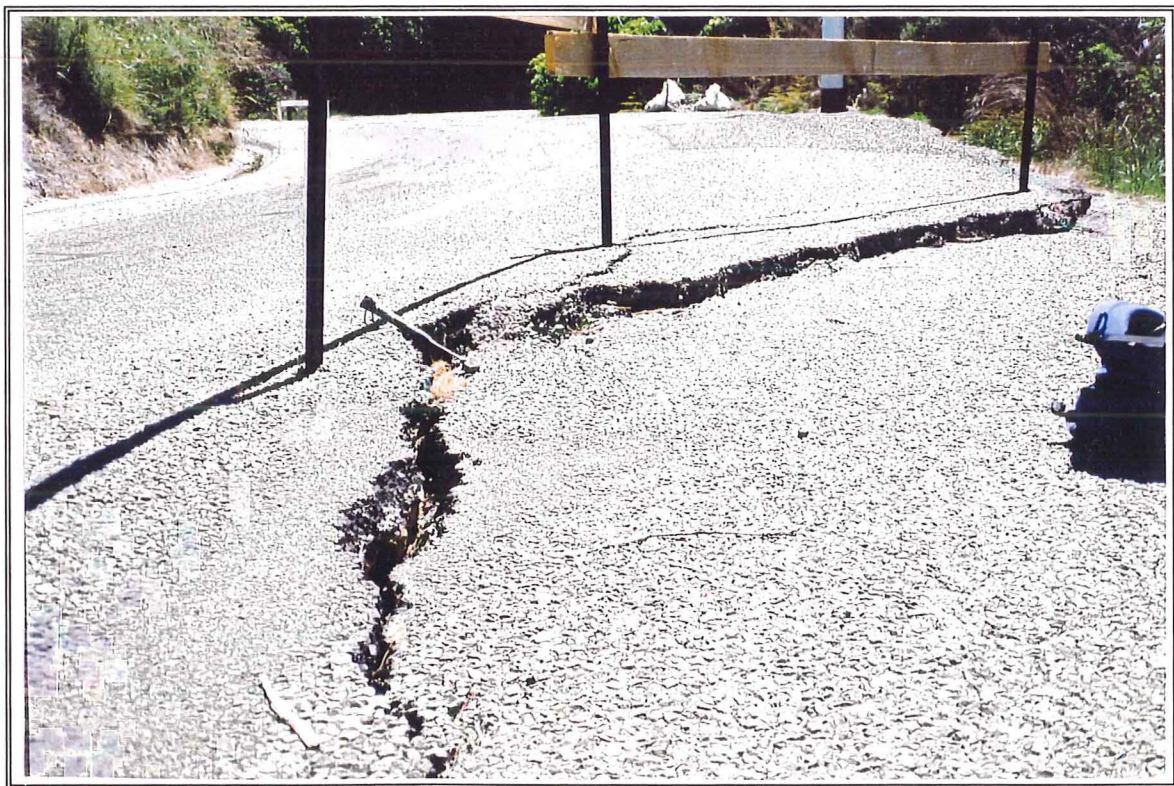
FIGURE 6.14.: Cracks which have formed in the Port Underwood Road following a rainstorm in November 1994. Approximately 20cm of slumping is related to failure in road fill and colluvial material down slope. Note, hammer for scale.

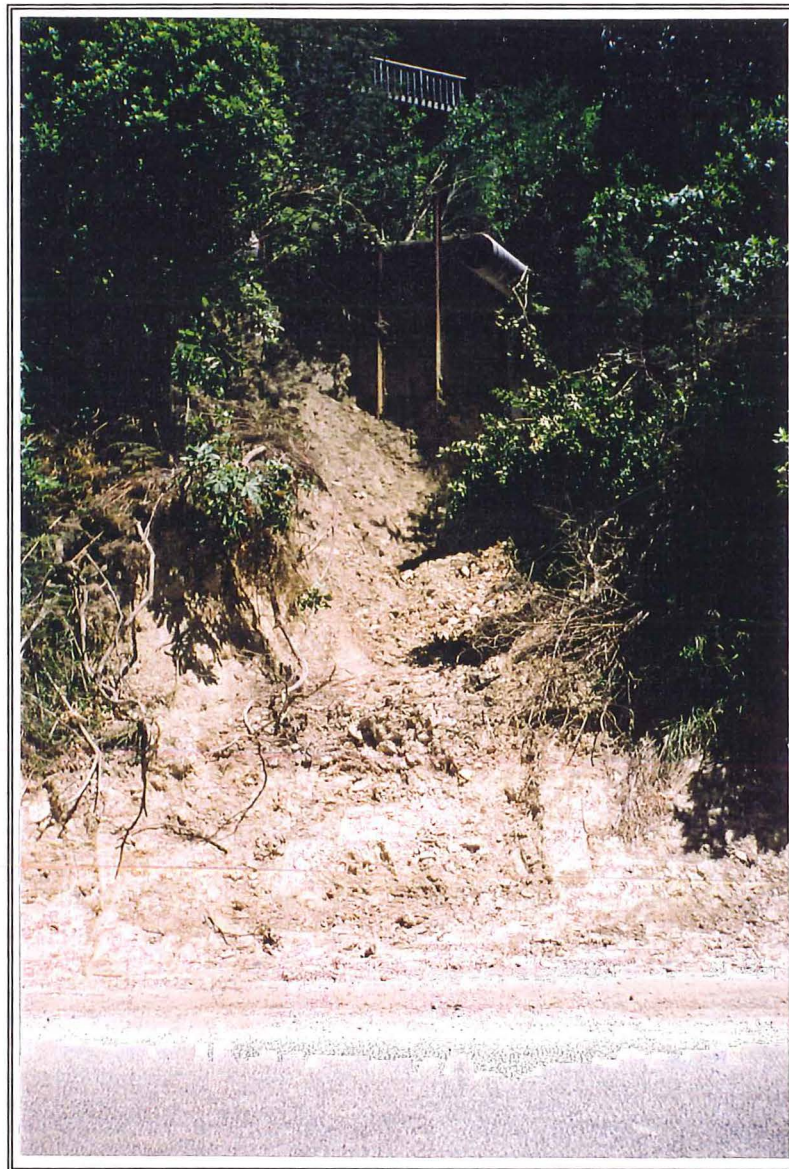
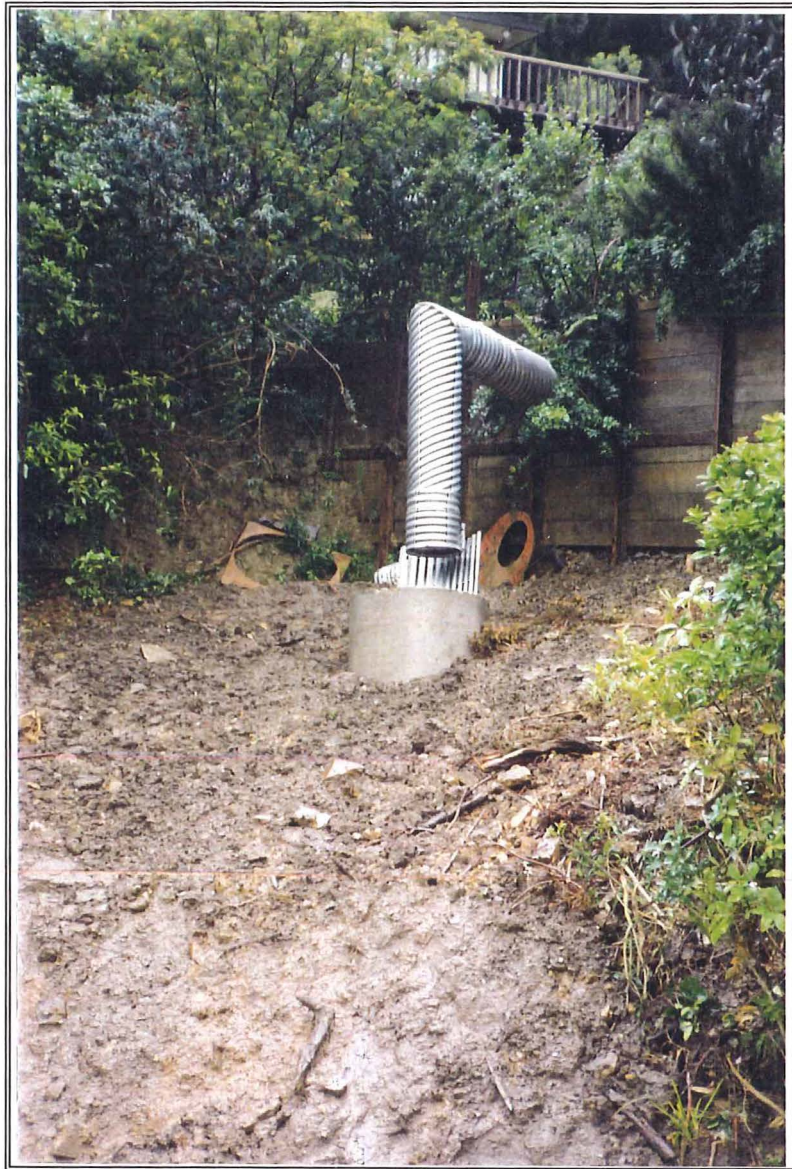
*FIGURE 6.16.: Poor storm water removal has lead to the failure of a relict colluvium filled gully below the access road to the house above. Photograph a) shows the damage caused by storm water disposal directly onto the rock/soil face.*

*FIGURE 6.16 (ctd.). Photograph b) shows the remedial measures which were employed and include re-culverting storm water under the Port Underwood road and replanting of the failure surface.*

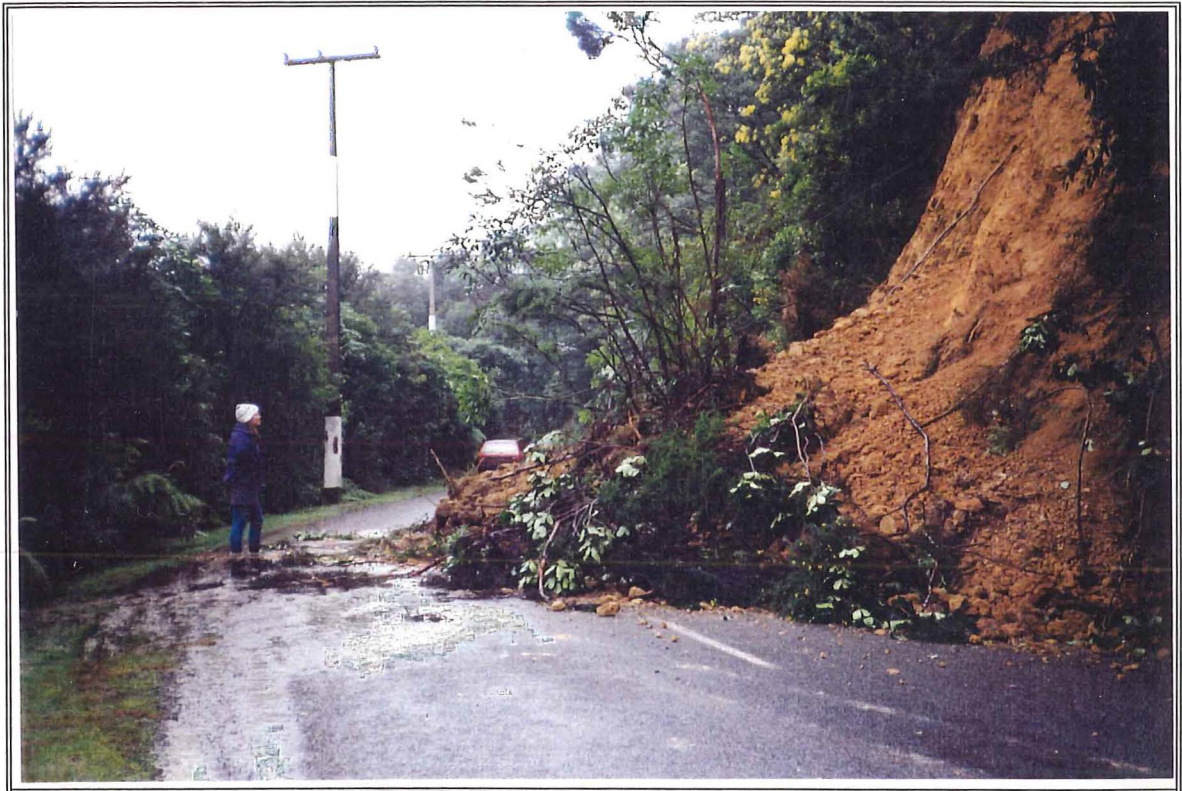
*FIGURE 6.18.: One of the road batter failures following heavy rain during August 1995.*

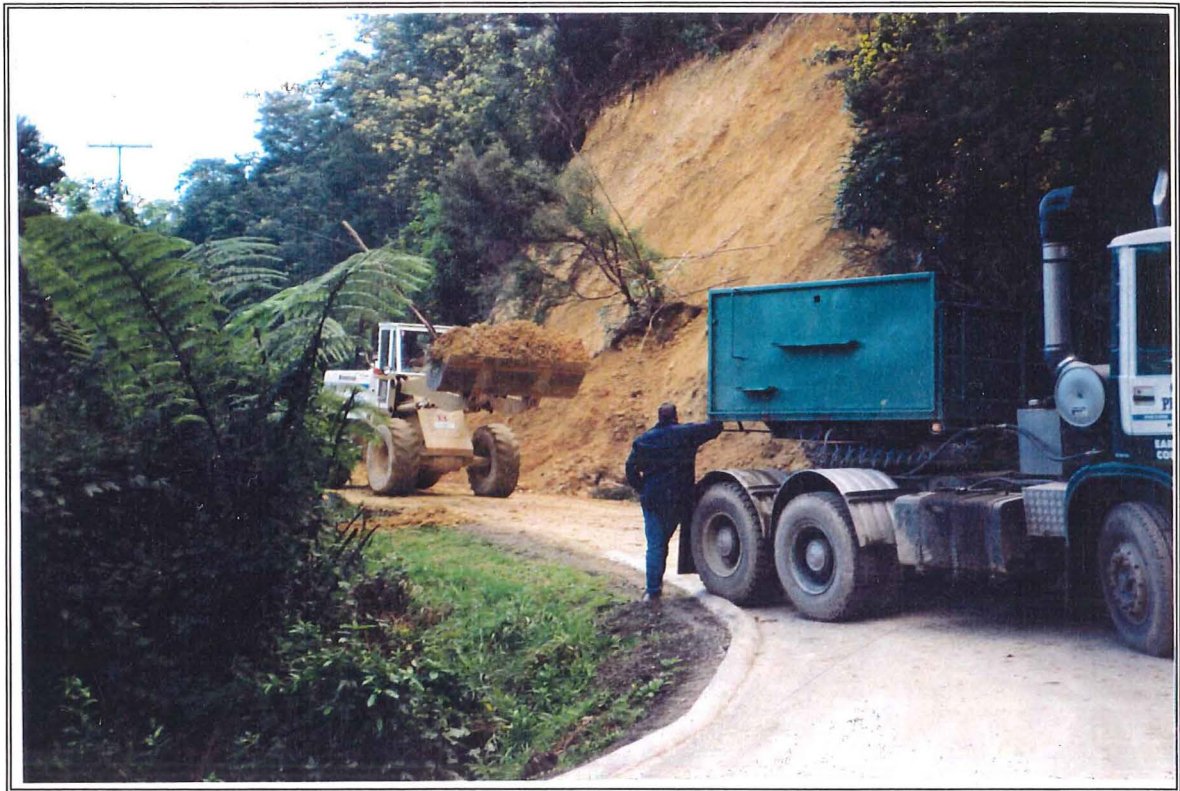
FIGURE 6.19.: The second failure of the slide in Figure 6.18. This failure shows another scarp developing north west of the main failure and is likely to fail during future rain storm events. Over  $300\text{m}^3$  of rock and soil were removed from this location and the failure measures approximately 15-20m high.

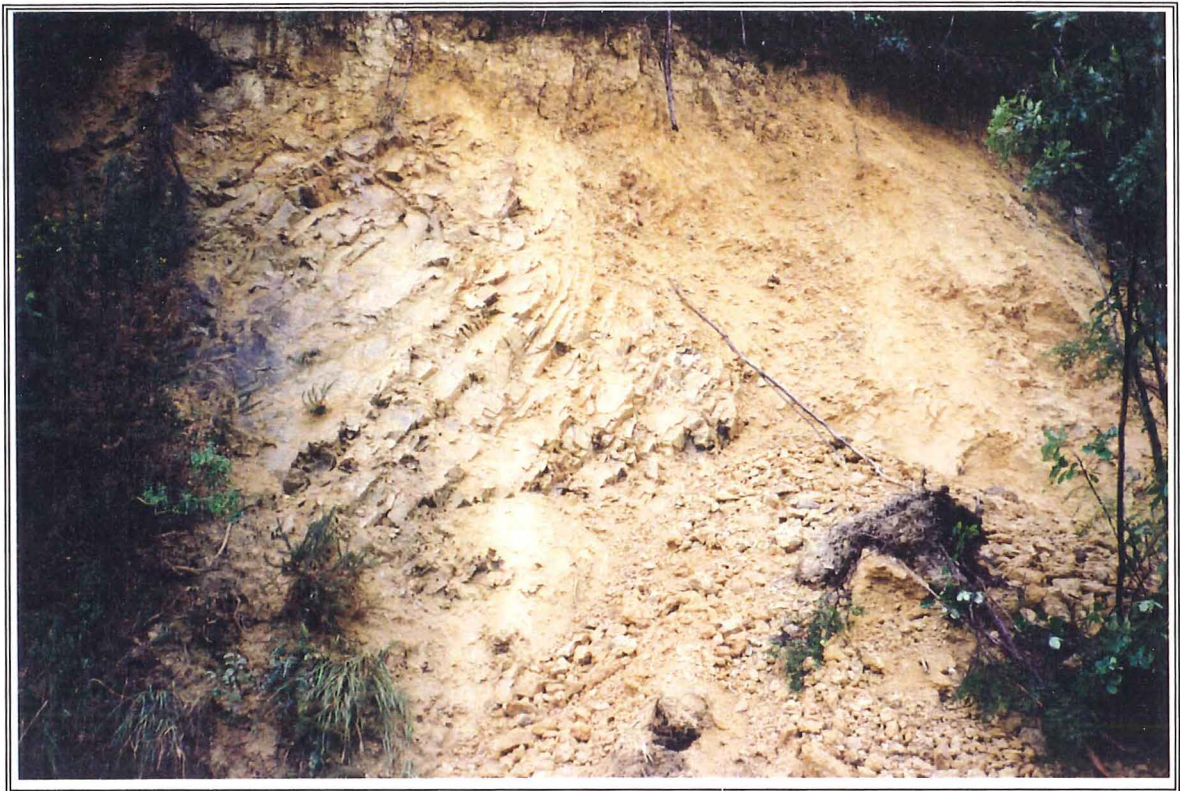
FIGURE 6.20.: The failure surface of the batter failures in FIGURE 6.18. and FIGURE 6.19. Note the steeply dipping joint surfaces along which planar failure has occurred.

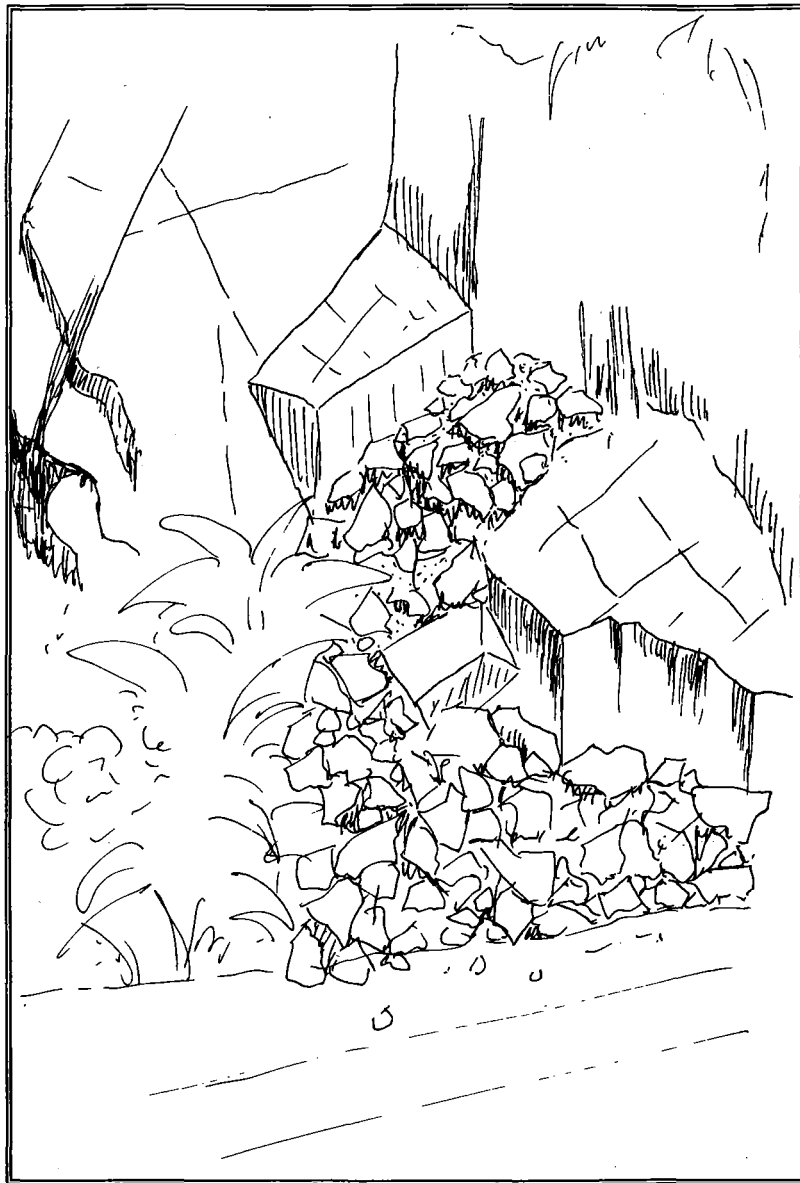
*FIGURE 6.21. A Photograph and sketch of a wedge failure on the forestry road above the Port Underwood Road in Whatamango Bay. Stereographic interpretation in given in FIGURE 6.22.*

*FIGURE 6.21 (ctd.): Schematic representation of wedge failure.*

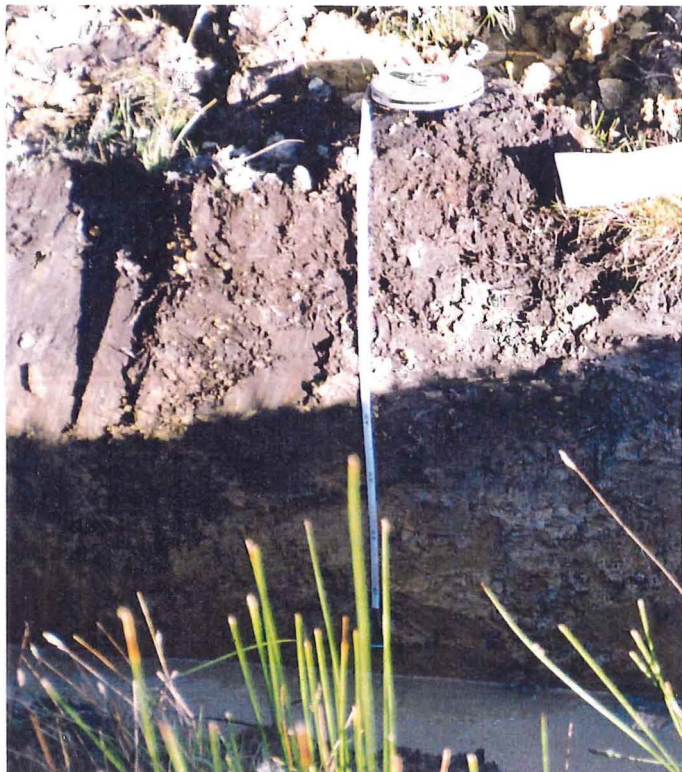
ENGINEERING GEOLOGY		TRENCH LOG		
PROJECT: B.Sc. Honours Project				
EXCAVATION DETAILS: Test Pit TP1				
LOCALITY: Smith Property, Moana View Rd.				
LOGGED BY: S.T. McManus				
DATE: February 8, 1994				
SITE SKETCH		KEY

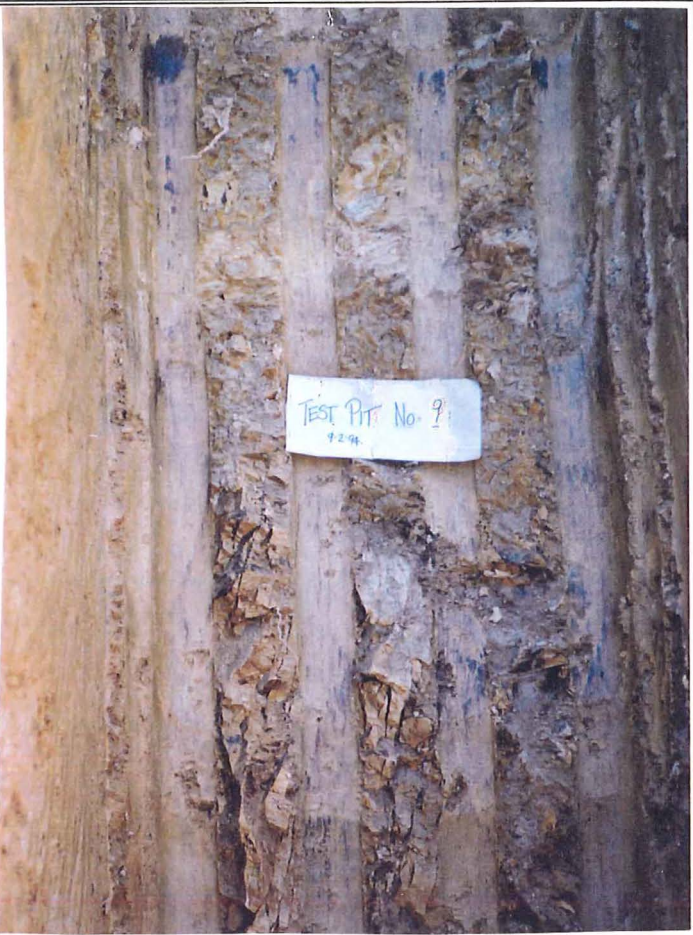
<b>EXCAVATION DETAILS:</b> Test Pit TP9				
<b>LOCALITY:</b> Smith Property, Moana View Rd.				
<b>LOGGED BY:</b> S.T.McManus				
<b>DATE:</b> February 8, 1994				
<b>SITE SKETCH</b>
